19 August 2020

**The Strata Committee  
Owners Corporation  
Strata Plan 3840  
C/- Body Corporate Services  
Locked Bag 22  
HAYMARKET NSW 1238**

**RE: 51-53 THE CRESCENT, MANLY 'THE PINES'  
TENDER OUTCOME REPORT – FAÇADE AND NOMINTAED BALCONIES  
DRAFT ONLY**

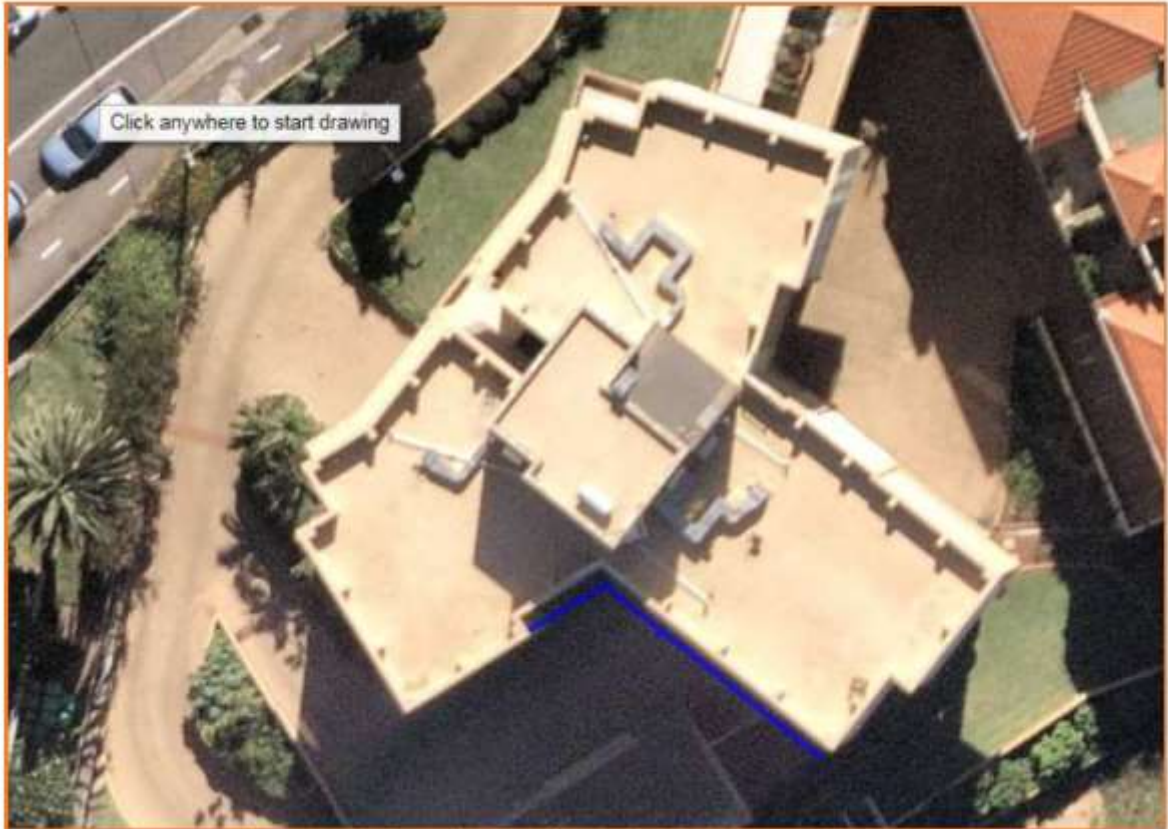
This item describes the replacement of the cavity flashings on the south east corner of the building where ongoing know cavity problems have occurred over a period of time. The brickwork is to be removed and all flashings replaced.

Area marked up in blue for cavity flashing replacement
